## ASSESSMENT OF DEBRIS FLOW DISASTER IN A RESERVE FOREST AREA, KERALA

A. K. Manoj\* & S. Sreekumar\*\*

**Cite This Article:** A. K. Manoj & S. Sreekumar, "Assessment of Debris Flow Disaster in a Reserve Forest Area, Kerala", *International Journal of Applied and Advanced Scientific Research*, Volume 2, Issue 2, Page Number 315-322, 2017.

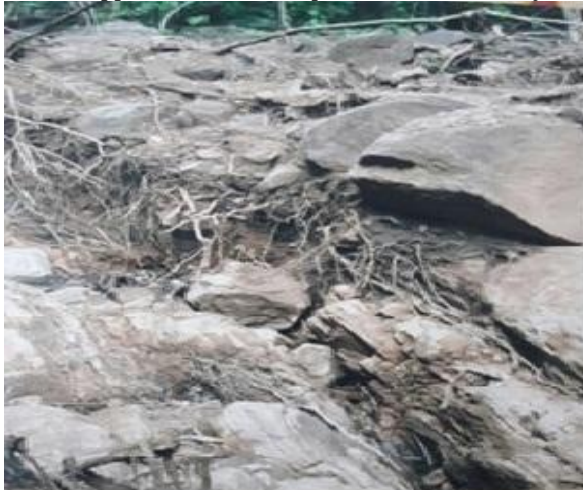
The landslide in the reserve forest area which occurred on 5<sup>th</sup> June 2004 (Fig 3a and 3b) belongs to debris flow category. The debris flowed very close to the settlement without devastating the houses. There were no casualties. The debris flow had its origin in a degraded forest patch. A streamlet was resulted when the failure happened and in later period it is marked by a small spring which appears only at the onset of monsoon.

Fig 3a: The initiation of debris flow by the wedge failure at the crown of the scar

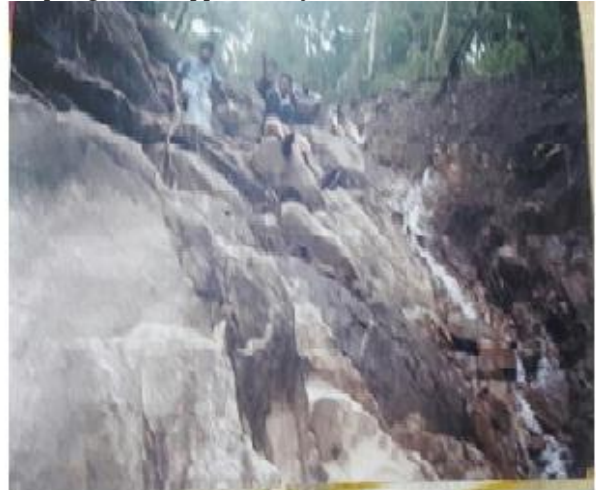
Fig 3b: joints dipping towards the hill slope favouring plane failure (middle portion)

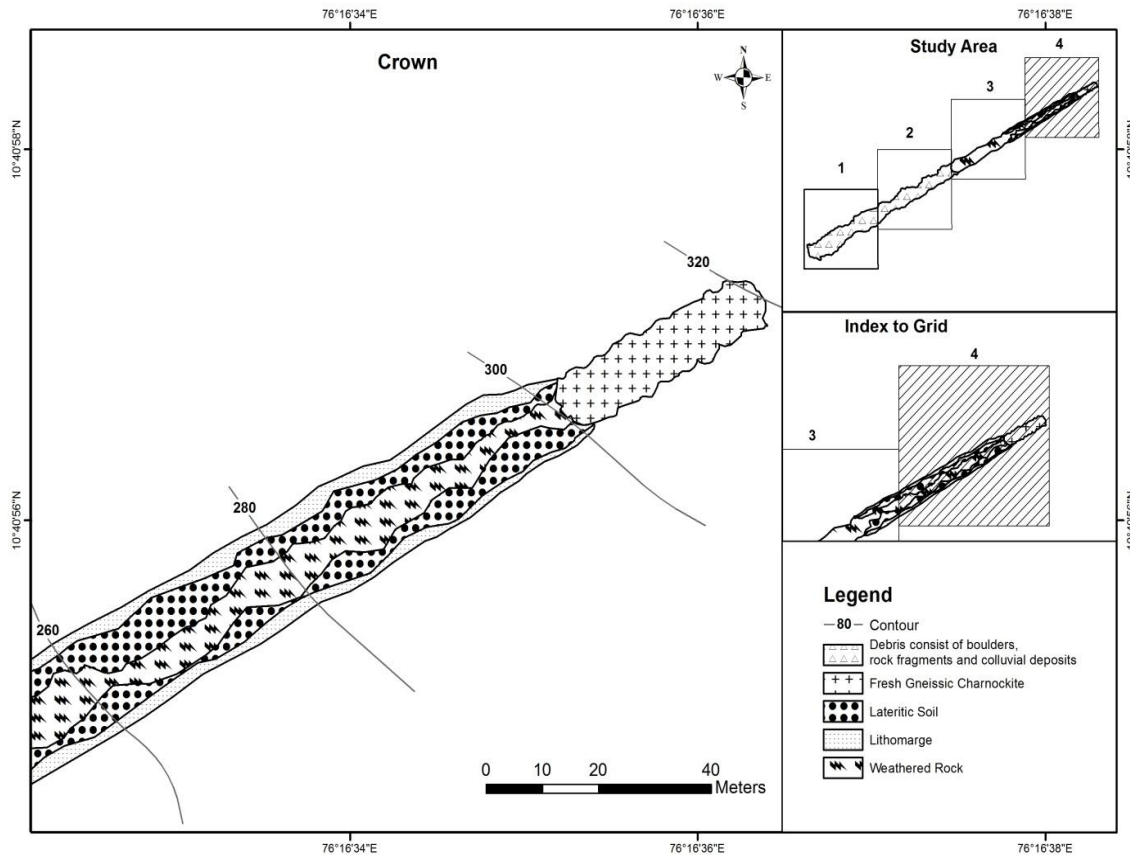
Figure 4a-d: Detailed geologic map of paleoscar

The detailed geological map of the failed slope from crown to the toe of paleoscar is presented in Fig 4a-d. The debris consisting of boulders of weathered rock, lithomarge, sand - clay mixture spread out to a wider area at the toe, where families live. As a consequence of this debris flow a deep crack has been developed in the upper and adjacent part of the slide scar, and making the slope vulnerable to further slope failures. The debris flow is left behind by numerous precariously perched boulders too.

The top part of the crown (Fig 4a) is composed of fresh charnockites which are traversed by joints. The scar is bordered by litho marge clay and laterite soil and its central part is occupied by weathered rock and angular boulders. In the middle part (Fig 4b and Fig 4c) the width of the scar increases but that of wethered rock narrows down. The flank consists of angular boulders laterite soil and lithomarge. Further down only weathered rock is exposed. In the toe part of the scar (Fig 4d) a heap of very coarse angular debris are observed.

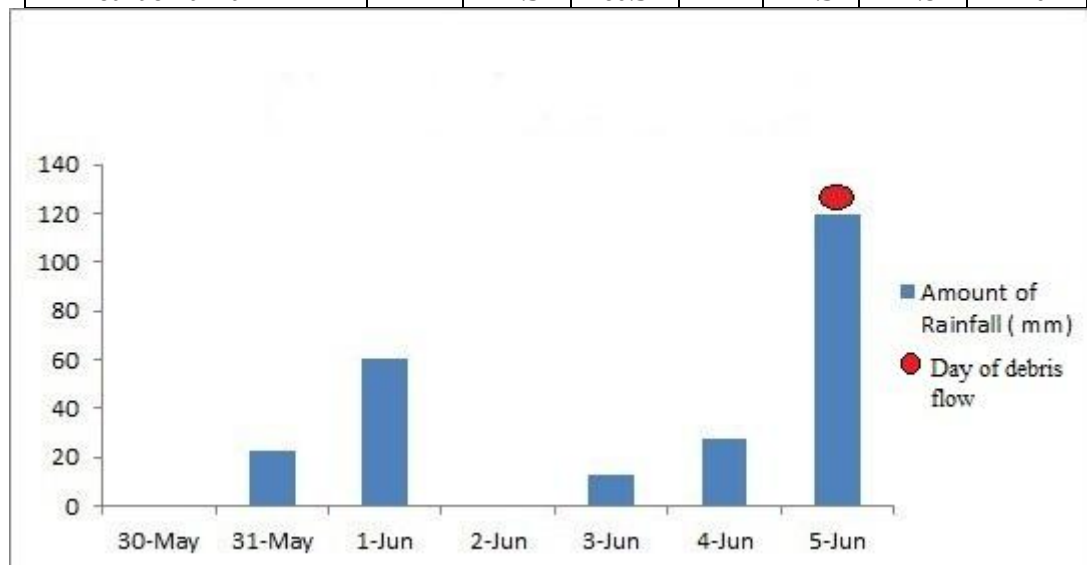
Figure 5: Rainfall (mm) received in the station prior to the debris flow

Successful relationship between rainfall and landslides in Western Ghats has been brought out by several researchers (Sekhar et al 2008, Thampi 1998, Sankar 1991, Sreekumar 1998, Sajinkumar et al 2011). One hundred and eighty millimetre rainfall for couple of days can be considered as a threshold value to alert the civic administration to get set for disaster management measures in (Sreekumar 1998). Thampi et al. (1998) suggested a minimum rainfall of 300 mm in 2 days as needed to initiate landslides in Western Ghats regions. Sekhar et al (2008) found that on day of mass wasting events in Aruvikkal catchment area, the region received about 200 mm rainfall and the 2-day cumulative rainfall was 278.4 mm. The 2-day cumulative rainfall coinciding with landslides was 315 mm. Monsoon was very active during the period of slope failure in the study area. The rain fall received for a period of seven days including the day of occurrence prior to the incidence of slide is presented in table 2 and Fig 5. Analysis of rainfall data for seven days including the day of incidence indicate that Akamala region received 243.4 mm rain prior to the slide.

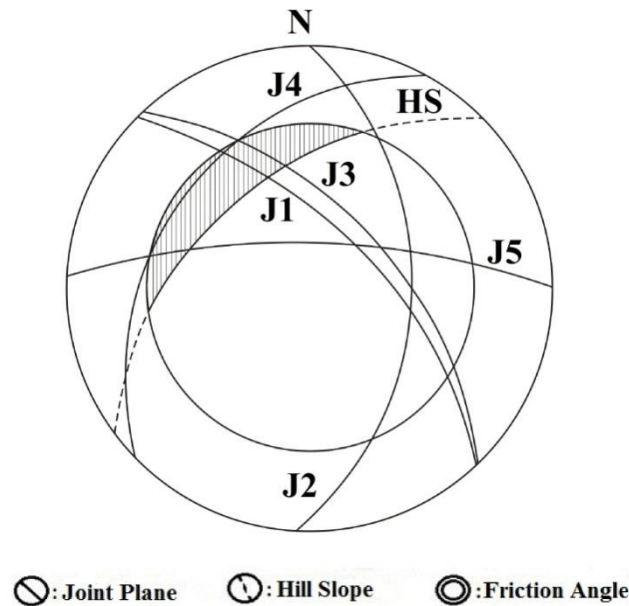
Figure 6: Stereographic Projection of Joints and their relationship with the material properties and hill slope. HS – Hill Slope, J1, J2, J3, J4 and J5 are the joints

The stereo plot of 5 major joints, hill slope and angle of internal friction of the weathered rock are presented in Fig.6. In this profile wedge failure occurred along the intersection of joints J3 and J4 within the crescent shaded area. The debris flow initiated with the wedge failure at the top. Consequent to the impact of slid rock and high water pressure activated planar failure down slope. J4 acted as the potential slide surface.

The field study indicates that chances of plane failure along joint J4 still exist in the location. During monsoon period the factor safety of the slope get reduced as the angle of internal friction decreases.

From the results it is obvious that the debris flow was resulted due to combined effect of the presence of potential joint planes and water ingress that reduces the normal stress to a level that accelerate failure. The vulnerability of slope failures would have been scaled down, if healthy wild trees were there. It is found that this debris flow occurred in a degraded reserve forest area.
